City of Coffs Harbour Review of Environmental Factors (REF)

Review of Environmental Factors under PART 5, Division 5.1
ENVIRONMENTAL PLANNING & ASSESSMENT ACT 1979 and REGULATION 2021 (Sections 170 & 171)

Project Name: Restoring the Magic to the Magic Pools on the Orara River, Dingo Creek Road, Upper Orara

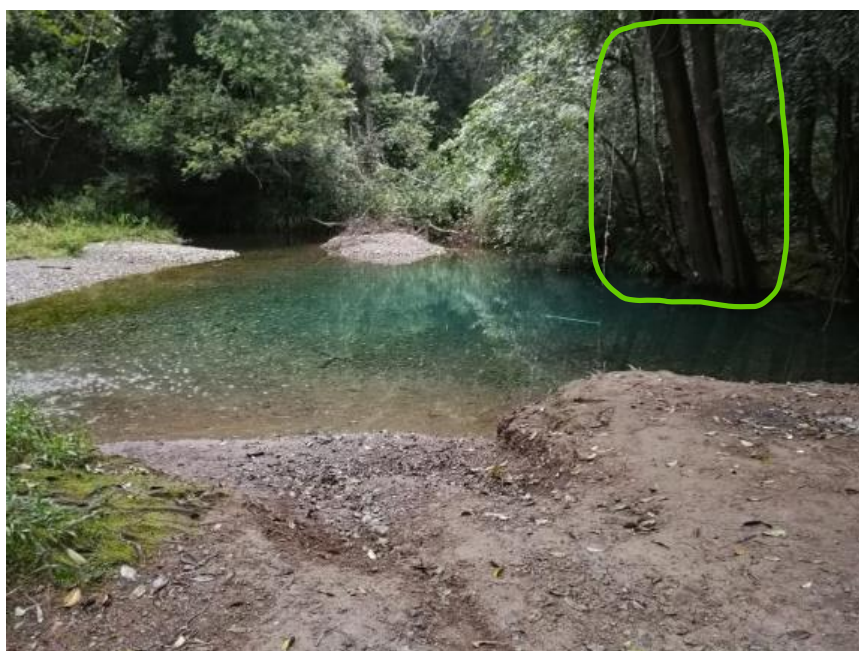
Image 2: Vehicle track marks entering the Magic Pools. This is not a road crossing so vehicles have to be towed out. The large River Oak shown in green with rope swing fell into the pool during the 2020 floods.

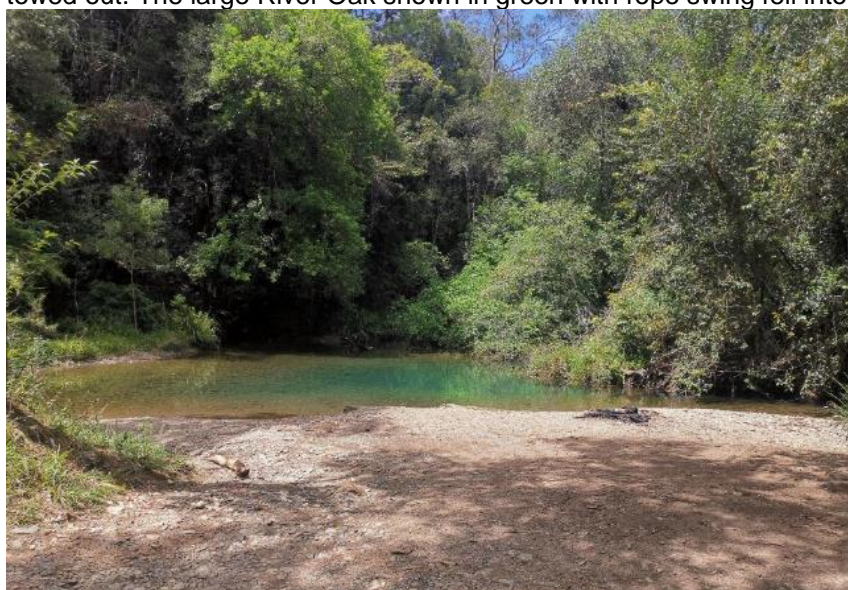
Image 3: Site 1 - The Magic Pool showing compaction of sediment as a result of vehicle asses and visitor use.

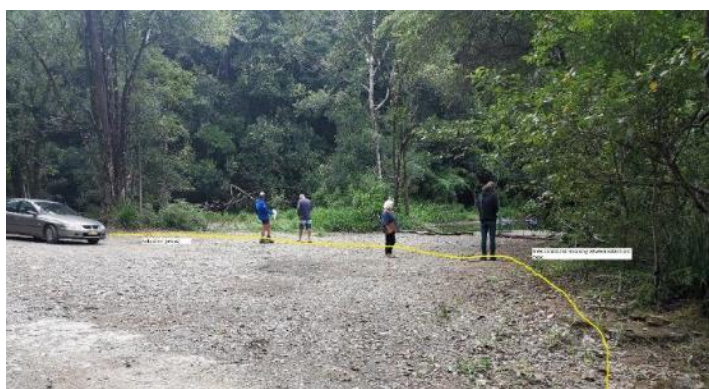
Image 5: Proposed bollard location with weed control and planting between the bollard line and the creek.

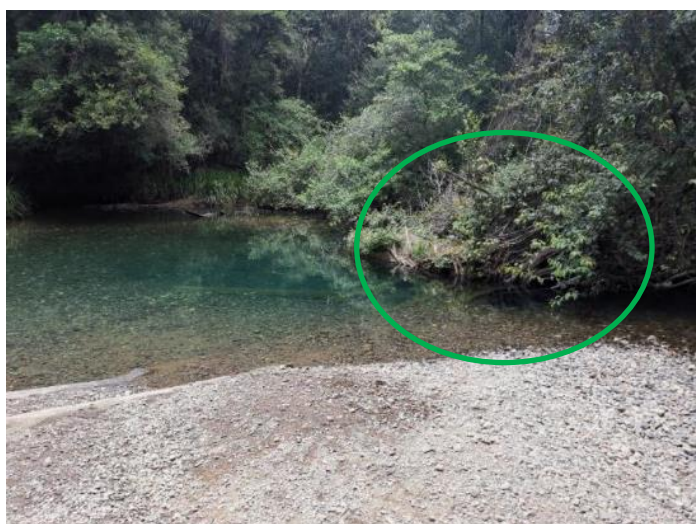
Image 6: Site 1 with the fallen river oak in the pool and covered in weeds – circled in green.

The project proposal will create a designated parking area within the road reserve, restrict vehicle entry to the waterway, repair the small erosion site on the bank of the river and realign the root wad of the fallen River Oak, with post works revegetation and weed control. These works will prevent further deterioration of the riverbank, reduce sediment loads, allow the ongoing transport of gravel from upstream, provide bank stability during floods, and provide a cleaner, safer swimming hole for visitors.

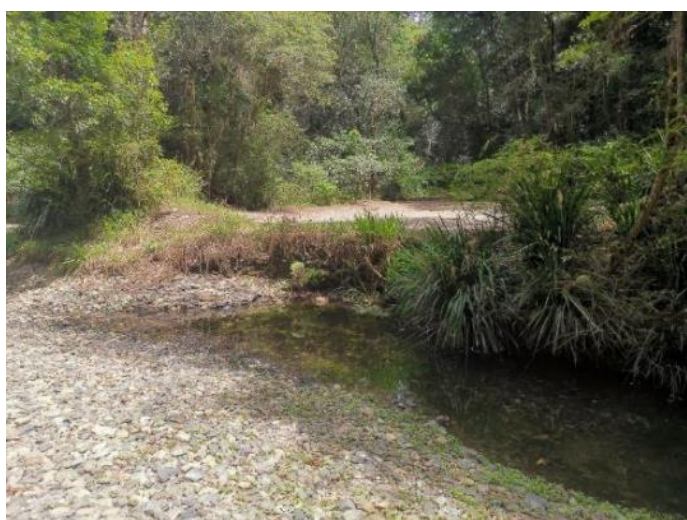
Image 8: Site 1 from the riverbed viewing the small erosion site caused by car access.

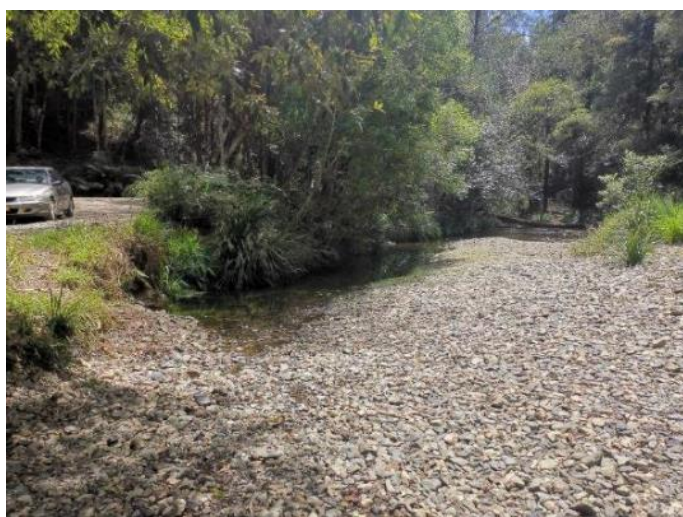
Image 9: Site 1 small erosion site looking downstream.

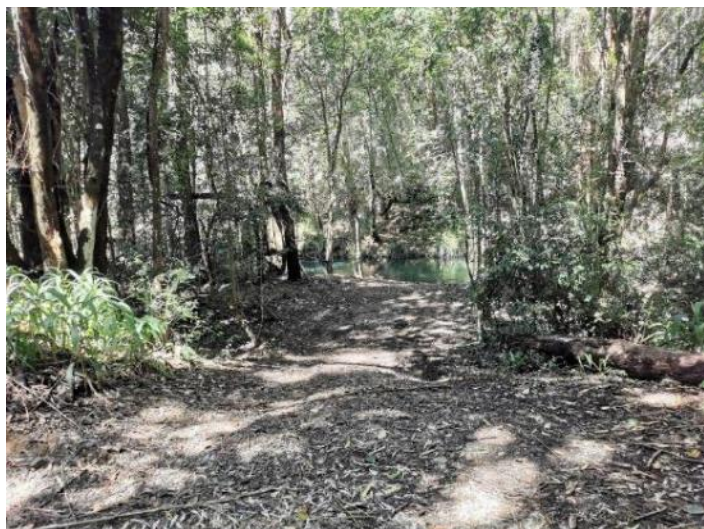
Image 10: Site 2 showing unauthorised vehicle access to the river and removal of native vegetation.

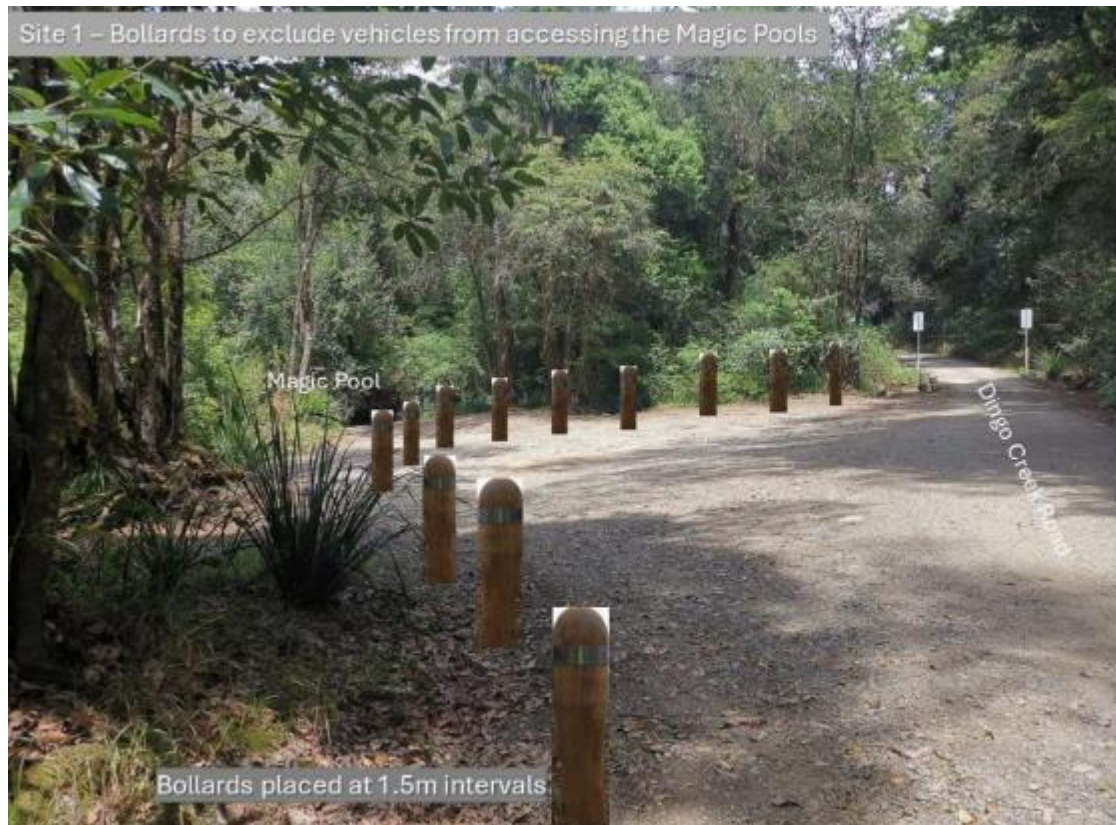
Bollards are 2.75m lengths of rail line placed 2m into the ground and capped with hardwood case. The rail line cannot be easily cut or pulled out of the ground. They will also withstand flooding

- The bollards will be a 2.75m length of steel rail line driven 2m into the ground, with the exposed section capped by a hardwood timber bollard. This ensures the bollards cannot be easily cut or pulled out, and are easily visible to visitors.

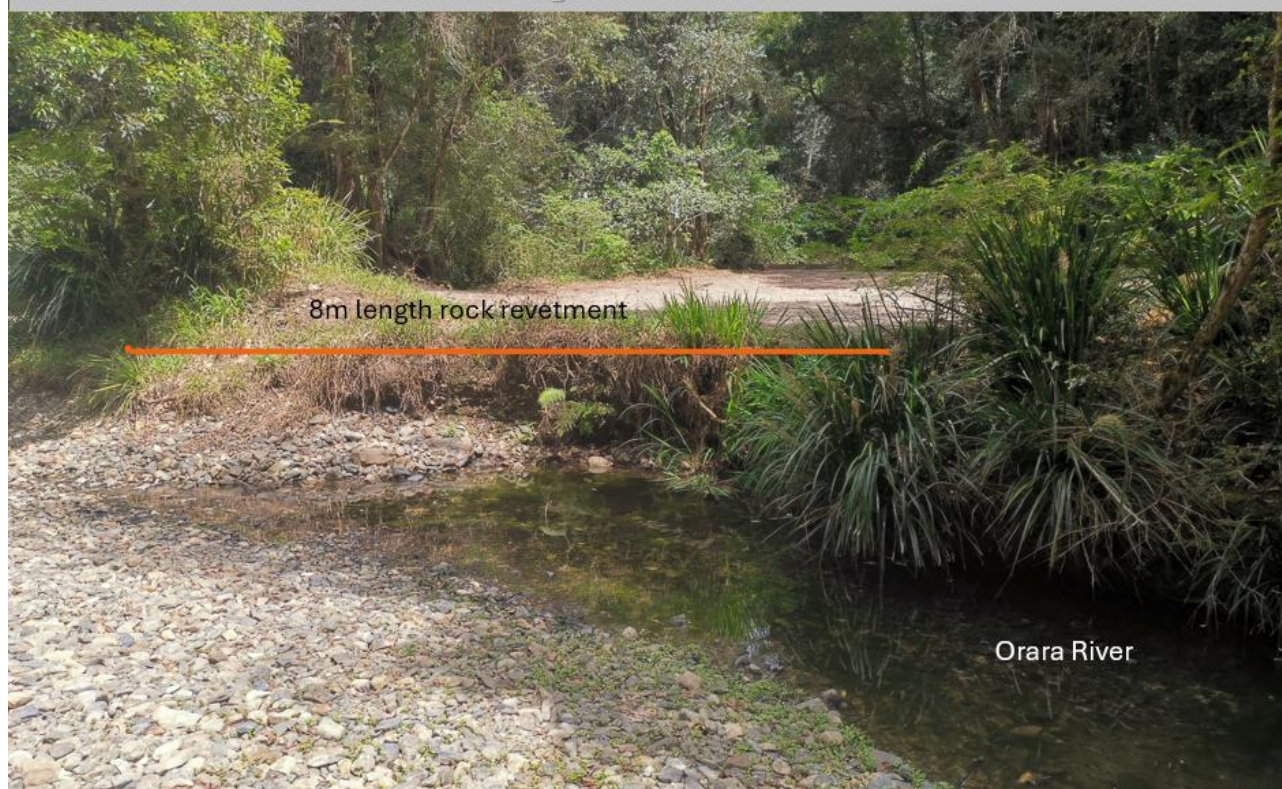
Rock revetment design for site 1

STANDARD ROCK REVETMENT DESIGN

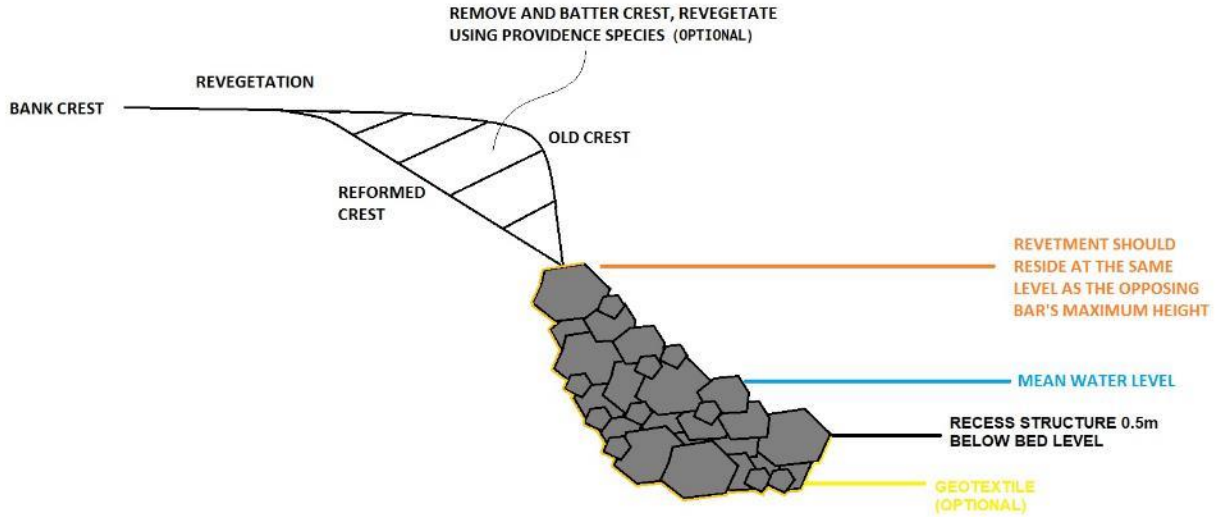
CROSS SECTION OF STANDARD REVETMENT DESIGN

<p>DESIGN NOTES: GEOTEXTILE IS NOT REQUIRED IF AN ADEQUATE MIX OF ROCK SIZES ARE UTILISED TO FILL VOIDS AND PREVENT SUCTION OF FINES FROM BEHIND THE REVETMENT</p>	<p>DRAWN BY: Shaun Morris Senior Land Services Officer</p> <p>DATE: JUNE 2024</p>	<p>PROJECT: Orara River Rehabilitation Project</p>
---	---	---

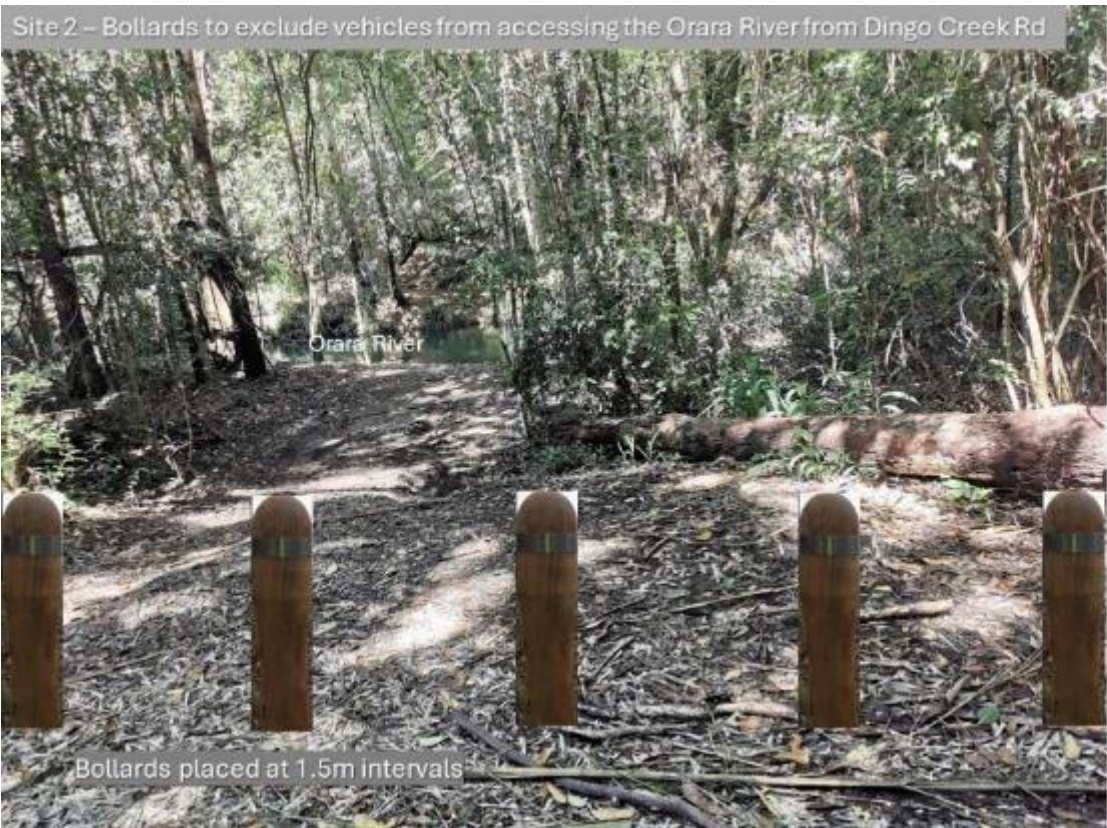
Site 2 – Bollards to exclude vehicles from accessing the Orara River from Dingo Creek Rd

Bollards are 2.75m lengths of rail line placed 2m into the ground and capped with hardwood case

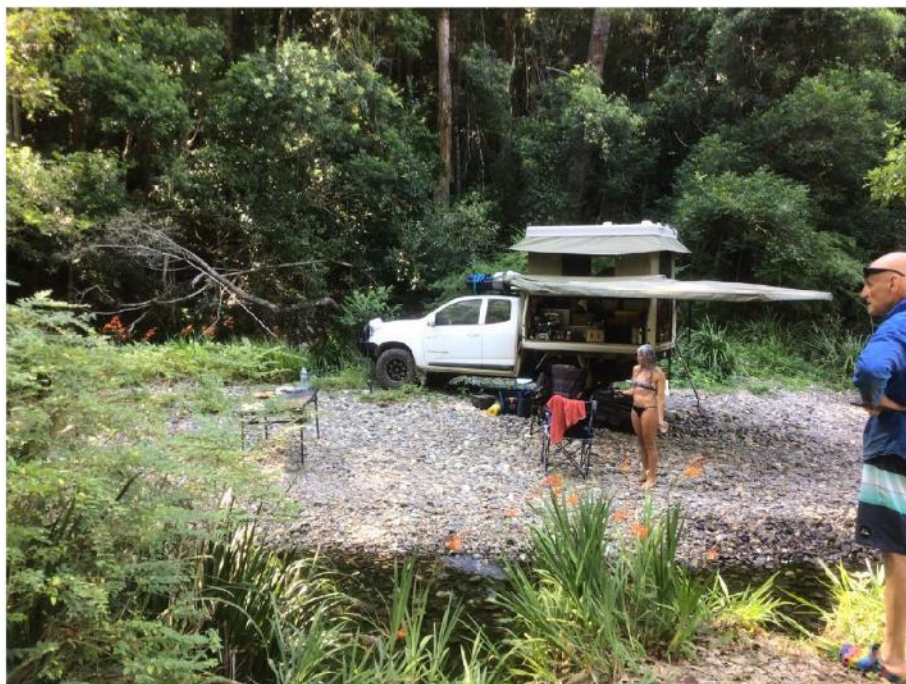
Figure 2 Long term camping on the river bed in the middle of the local breeding stronghold of *Mixophyes iteratus*

- Pollution: the washing down of 4WD vehicles on the river bed at the pools depositing toxic grease and oils/fluids; long term camping on the river bed where fluids and lubricants leak in to the river; human defecation close, hard up to, and even in the river; used nappies and wet wipes; slicks of sunscreen and the grease from discarded fried foods; takeaway containers of all kinds; petroleum based fire starters; syringes; and broken glass (figure 2)

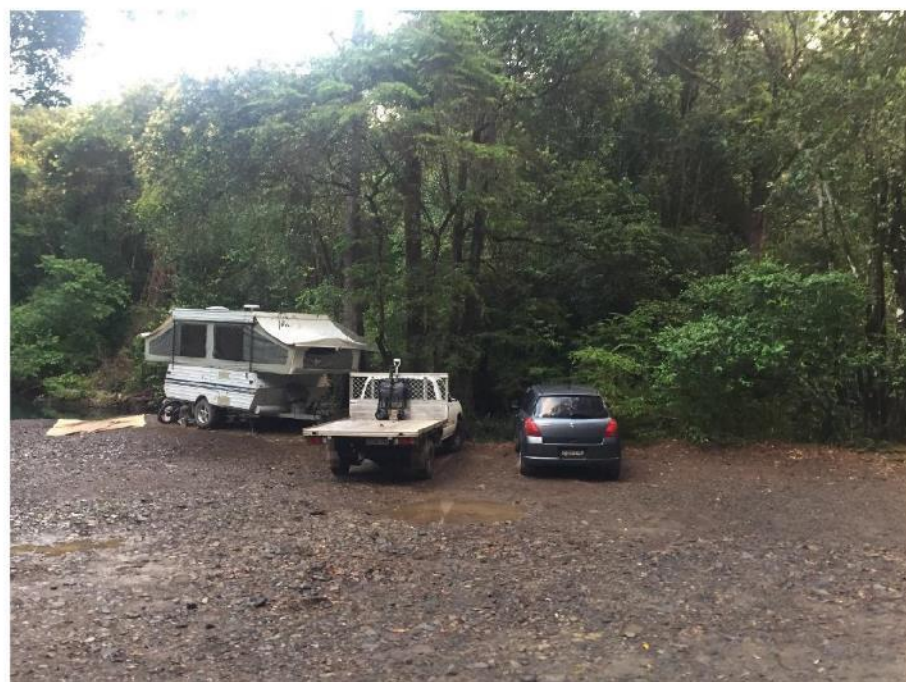
Figure 3 Caravan parked on exposed river oak tree roots

- Major bank slumping: a bend in the river is held by two river oaks whose exposed roots are constantly being driven over and parked upon (figure 3). It is only a matter of time until this kills the trees, leading to tree fall and major changes in local hydrodynamics

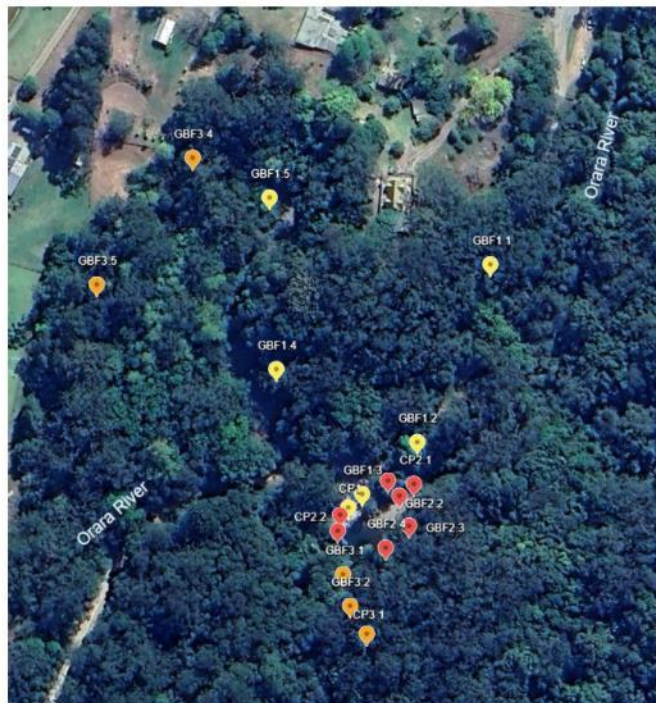
Figure 7 Survey sites close to the Magic Pool site

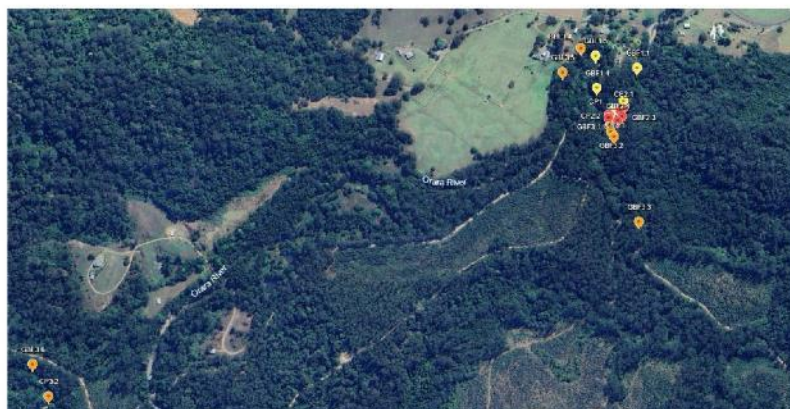
Figure 8 All survey sites
